# NEARSHORE HYDRODYNAMICS DURING HURRICANE MATTHEW

Patricia Chardón-Maldonado<sup>1,2</sup> (patricia.chardon@upr.edu), Miguel Canals<sup>1,2</sup>, Gabriela Salgado<sup>2</sup>  
<sup>1</sup>Caribbean Coastal Ocean Observing System, University of Puerto Rico at Mayagüez  
<sup>2</sup>UPRM Center for Applied Ocean Science Engineering, Department of Engineering Science and Materials

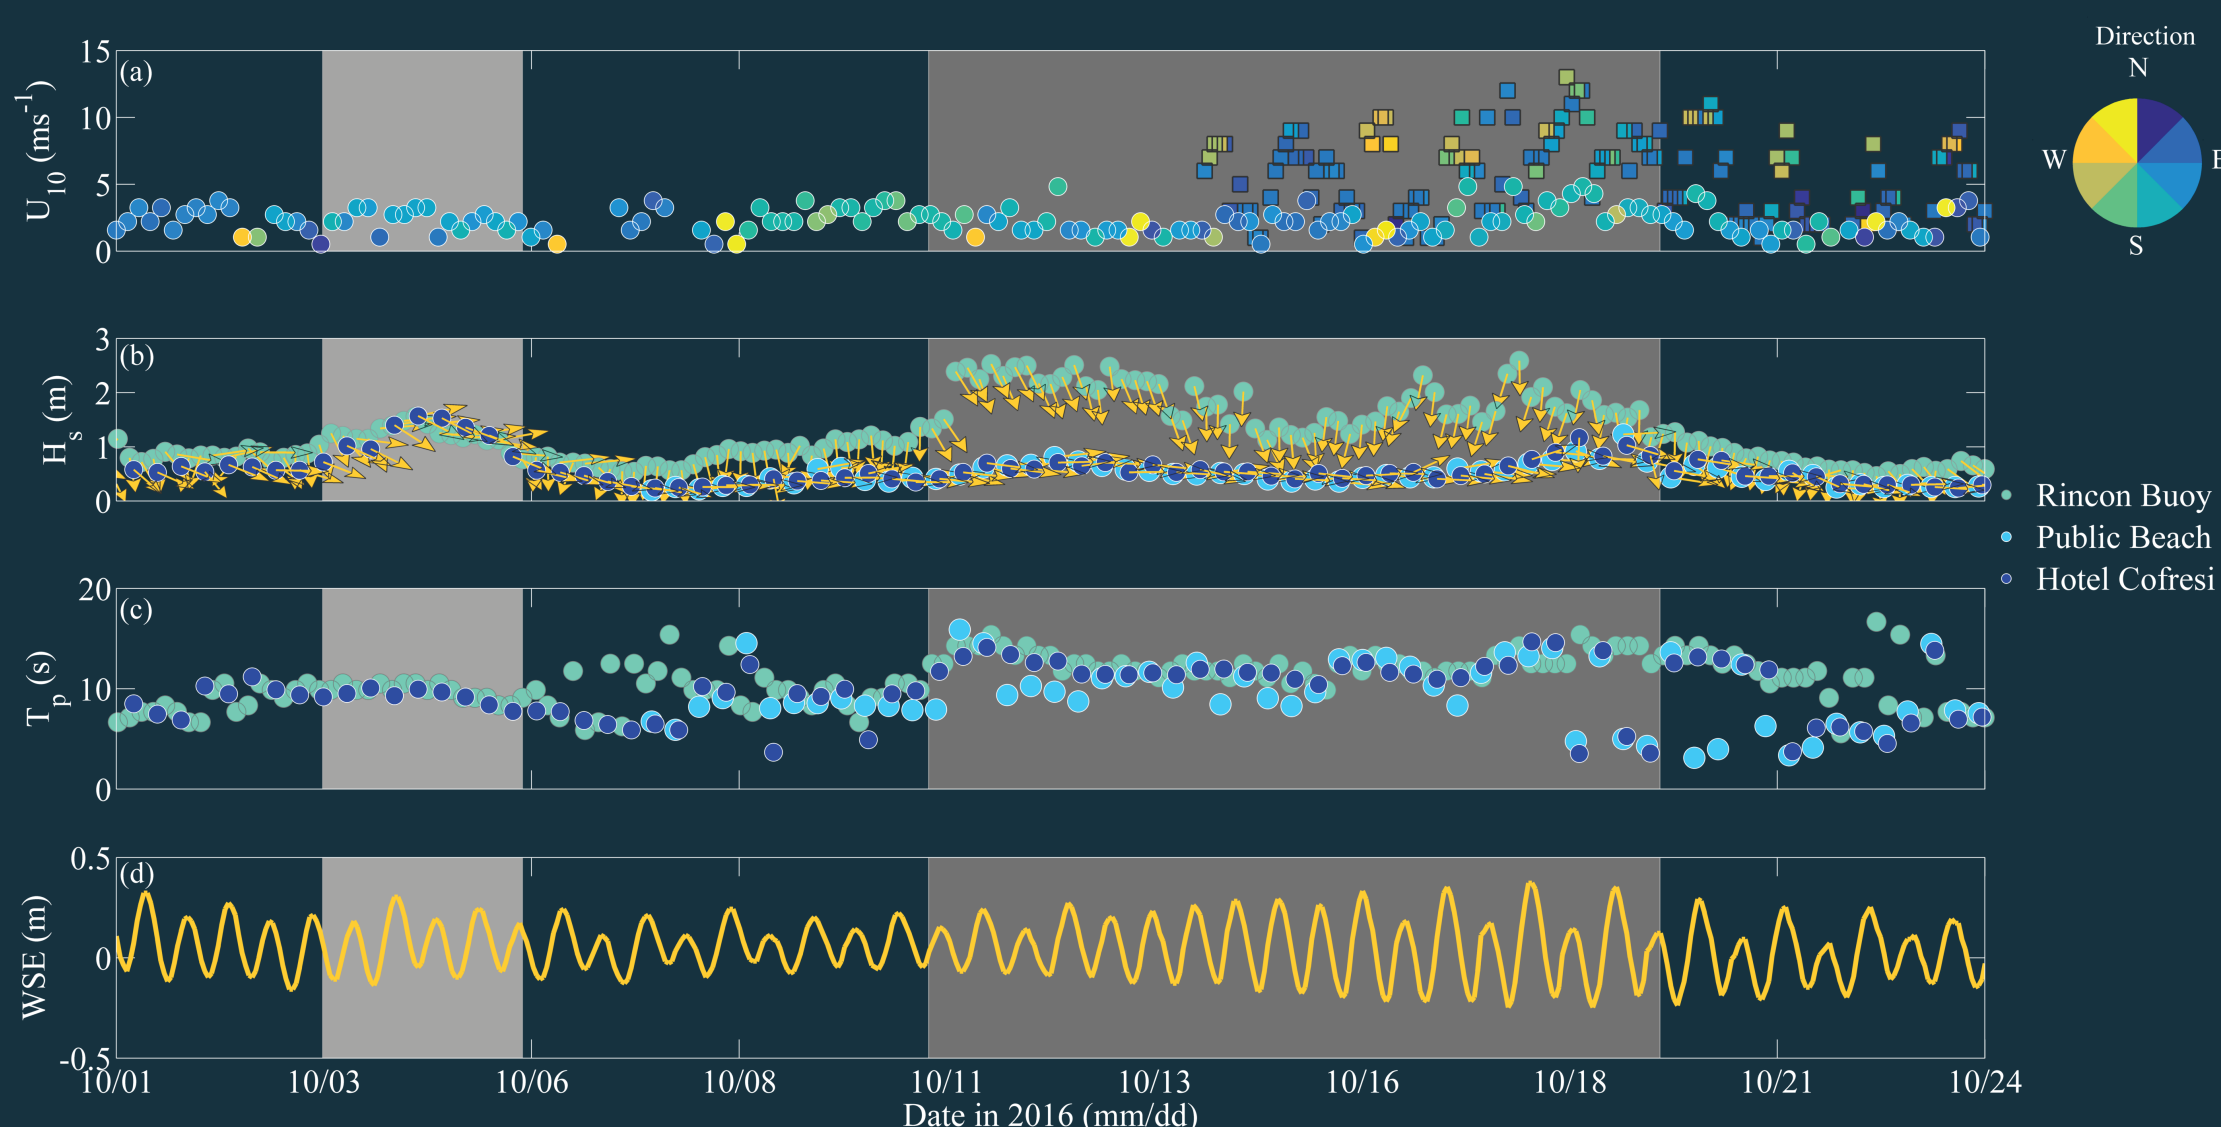
Offshore and nearshore wave and wind data were collected with CariCOOS Rincón wave buoy, 2 acoustic Doppler Aquadopp Profiler (Aquadopp) and 2 local anemometers.

Figure 3 Offshore and nearshore conditions at the CariCOOS Rincón wave buoy (dark blue), Rincón Public Beach (light blue) and Hotel Cofresi (green) during the study period: (a) wind speed ( $U_{10}$ ); (b) significant wave height ( $H_s$ ); (c) wave period ( $T_p$ ); (d) water surface elevation (WSE). Gray shading indicates the duration of the waves events caused by Hurricane Matthew. The color scheme in panel (a) depicts the direction of the winds and the vector in panel (b) indicates the direction of the waves.

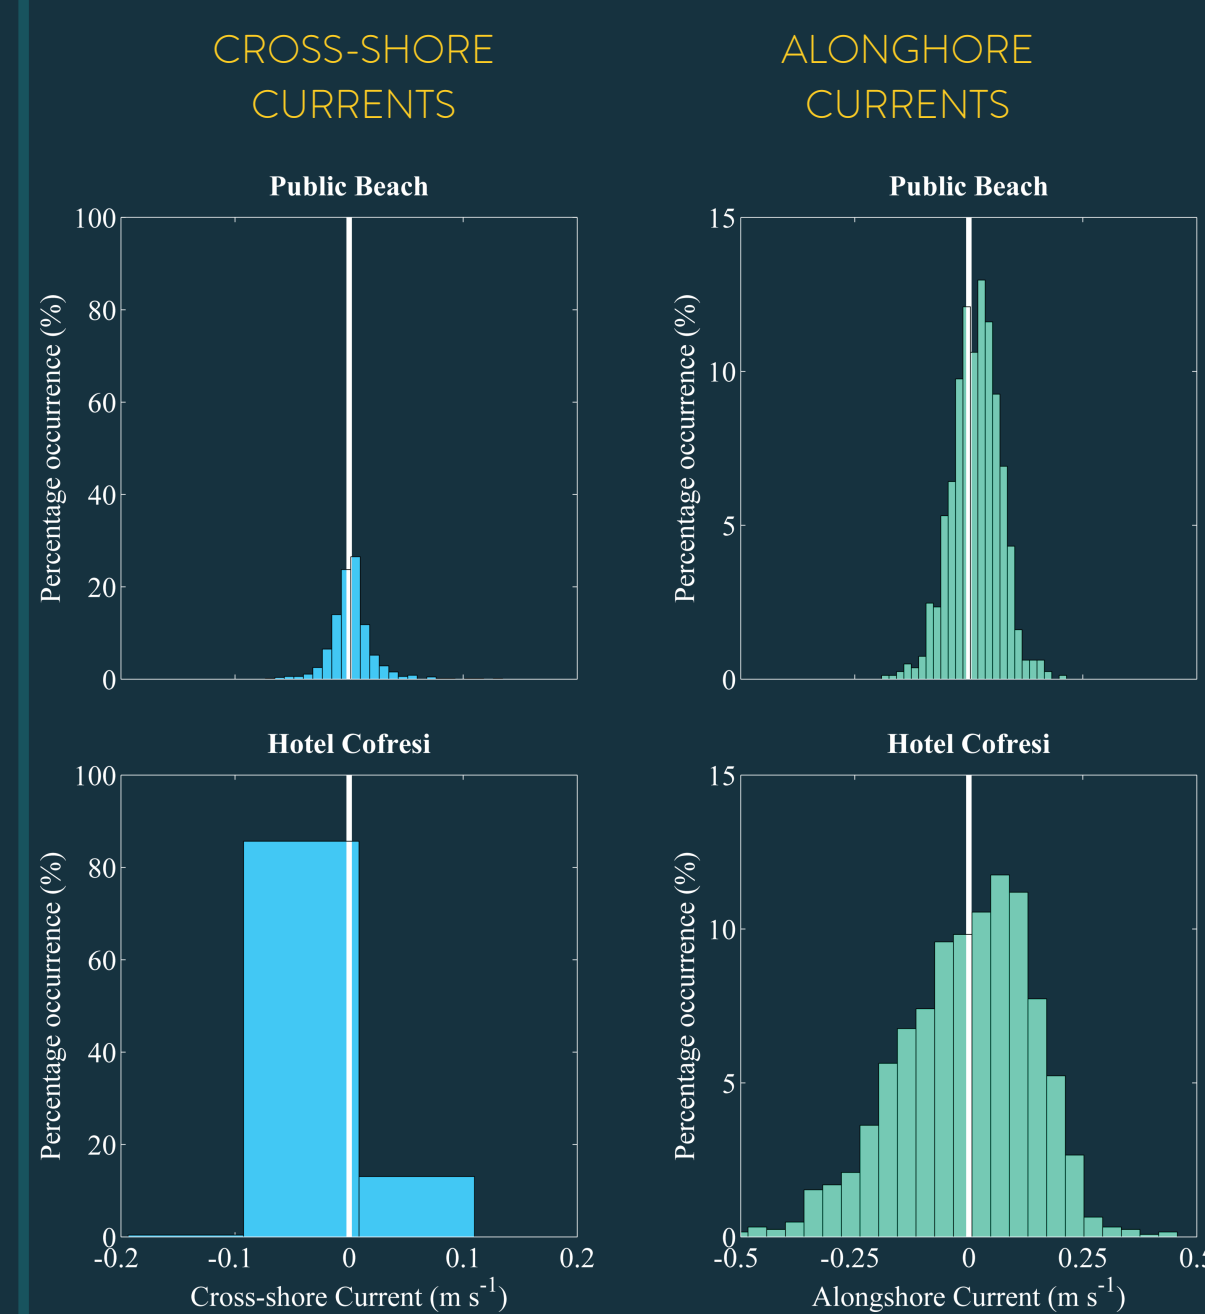
Currents are predominantly directed alongshore and the velocity field is relatively depth-uniform.

Figure 4 Distribution of the [LEFT] cross-shore and [RIGHT] alongshore current velocities at [TOP] Rincón Public Beach and [BOTTOM] Hotel Cofresi.

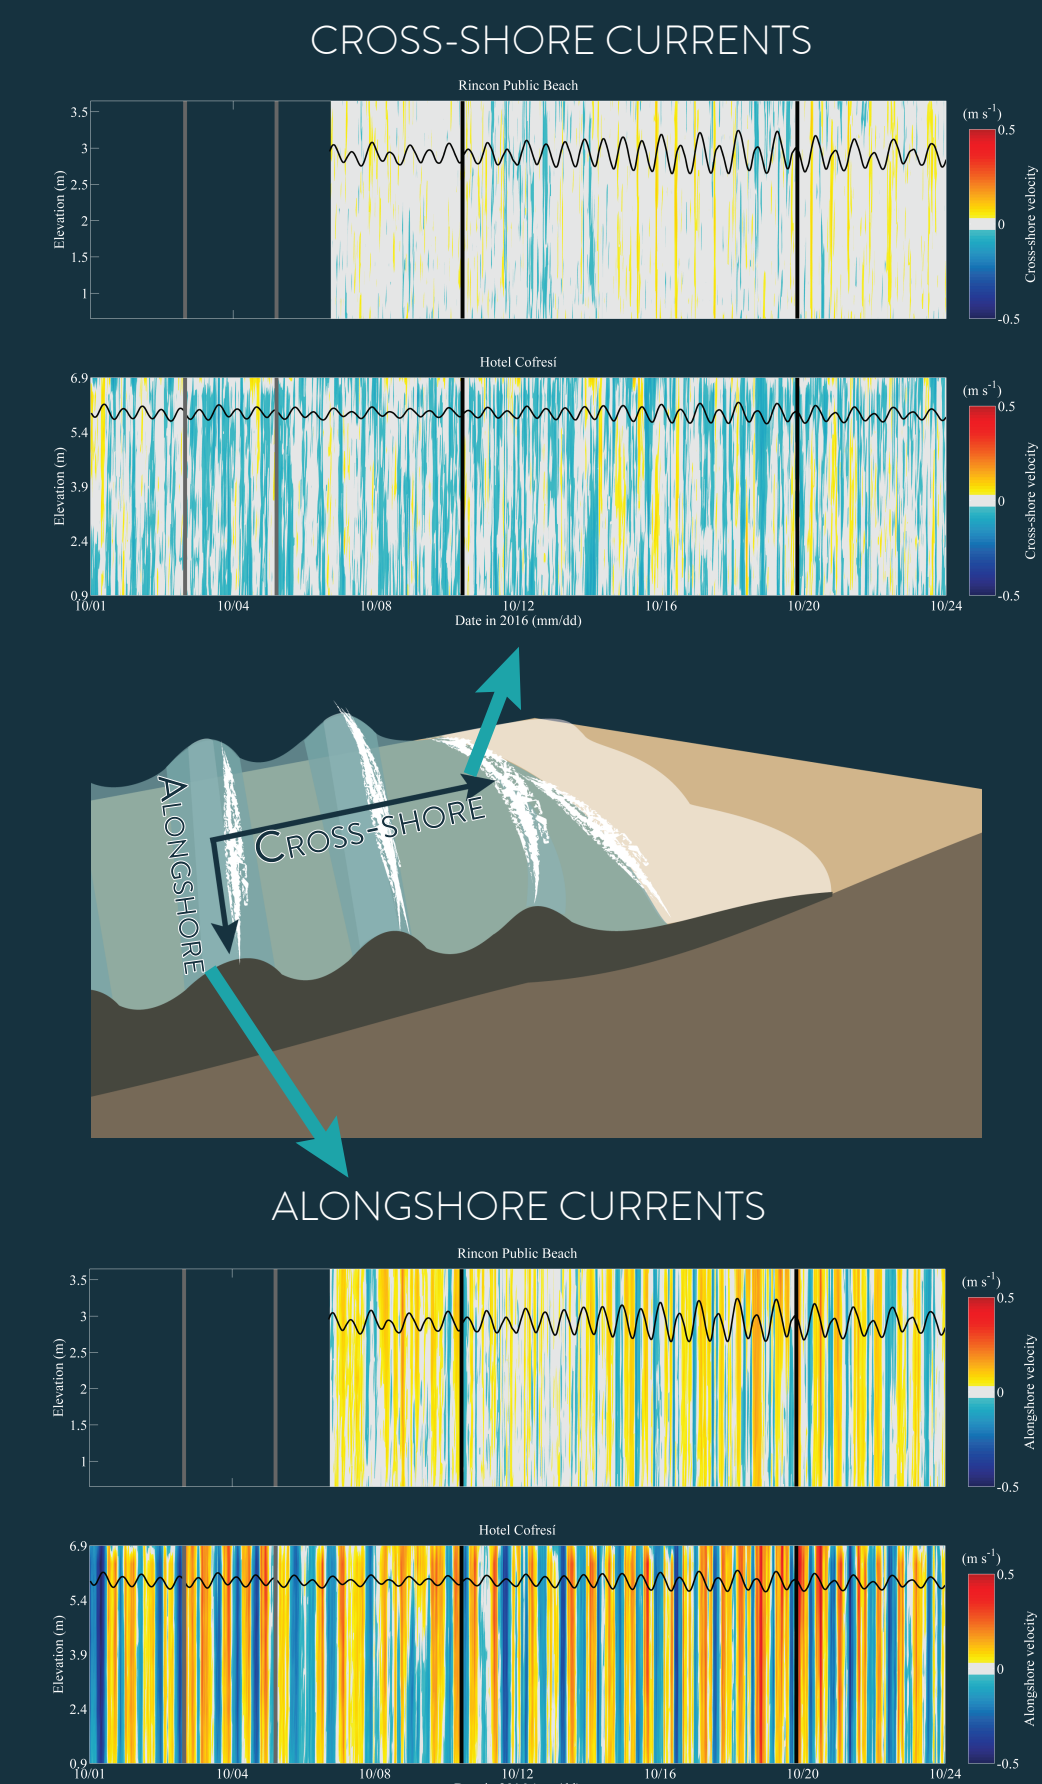
Figure 5 Vertical profile of [TOP] cross-shore and [BOTTOM] alongshore current velocity at Rincón Public Beach and Hotel Cofresi.

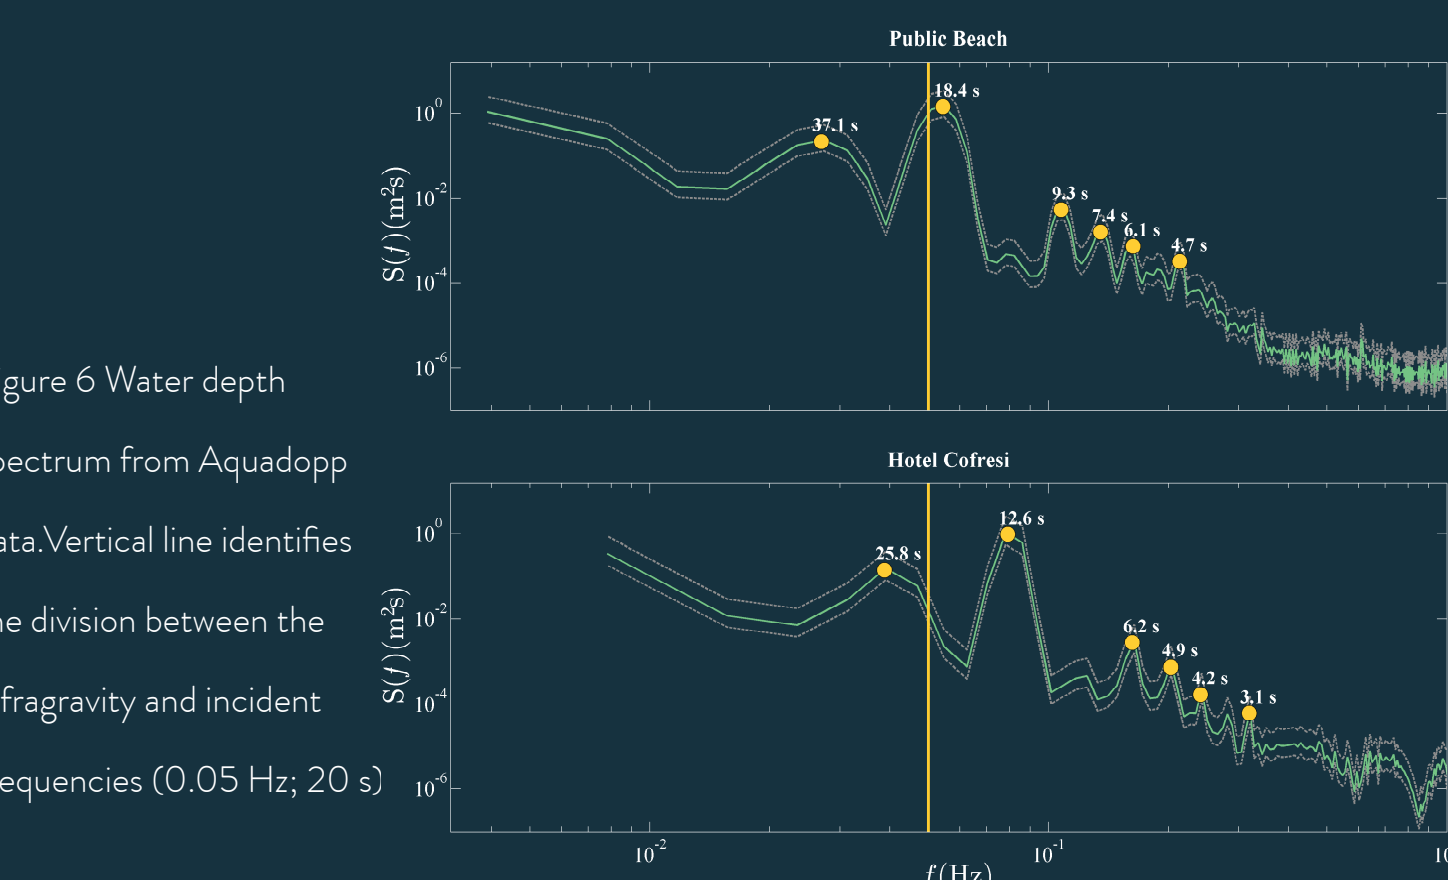
The well defined primary peak in the short-wave frequency, smaller secondary peak at the first sub-harmonic, and a peak in the long-wave frequency band, characterize Rincón's beach as a reflective beach.

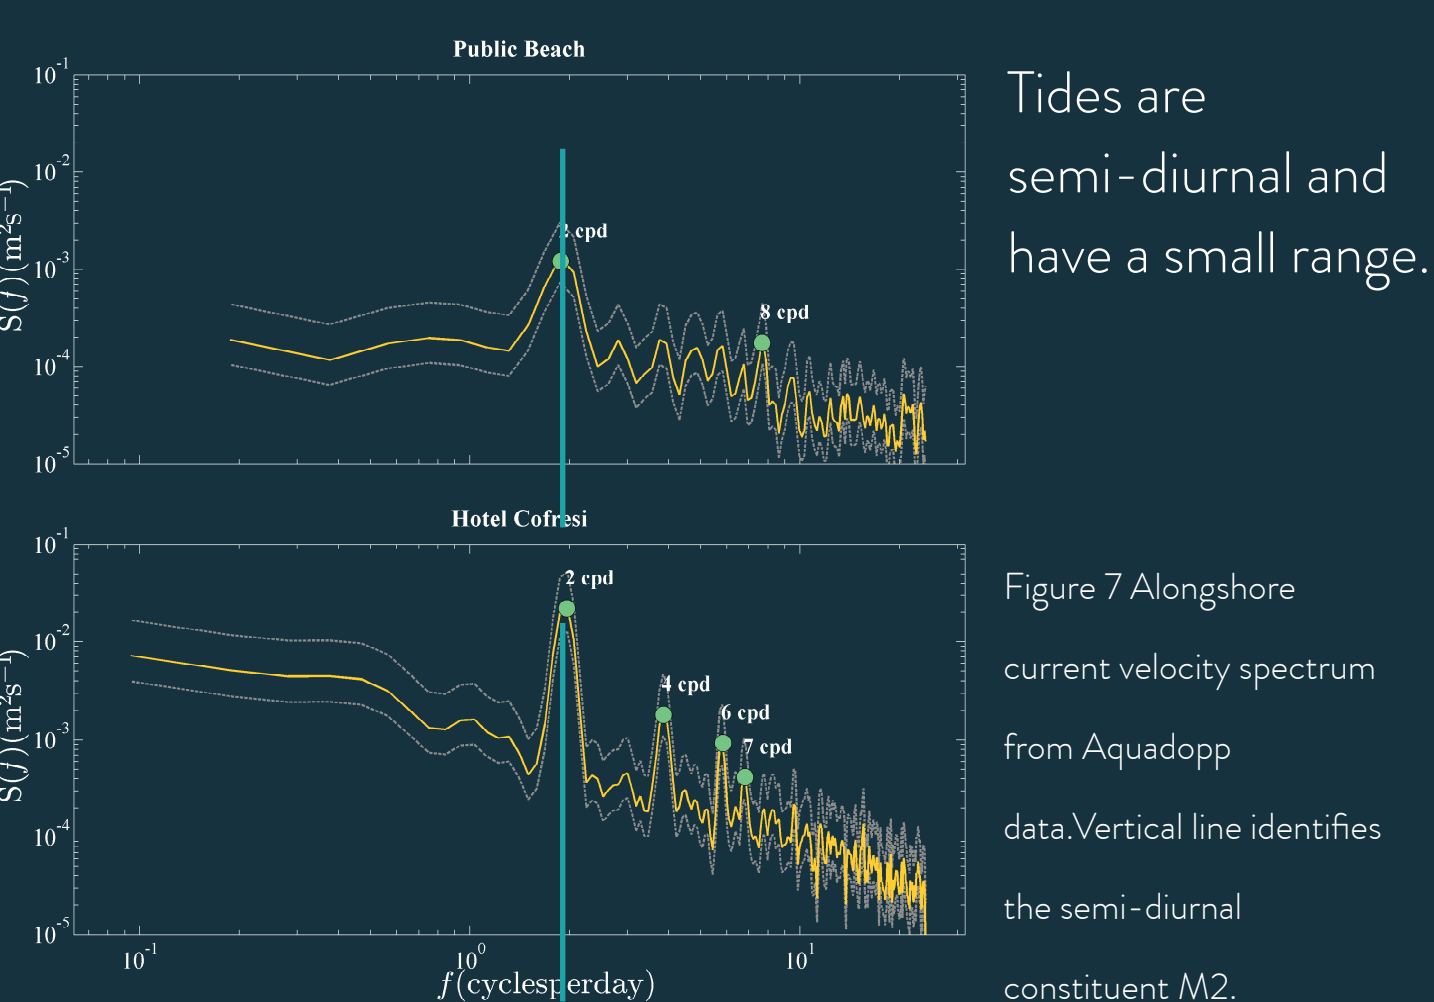
Tides are semi-diurnal and have a small range.

Figure 7 Alongshore current velocity spectrum from Aquadopp data. Vertical line identifies the semi-diurnal constituent M2.
