On September 20, 2017, Hurricane María made landfall in Puerto Rico, causing severe damage across the island and the mete-ocean conditions caused coastal erosion along the 700 miles of coastline. This coastal problem was more severe in the western region of Puerto Rico, particularly along the coast of Rincón.

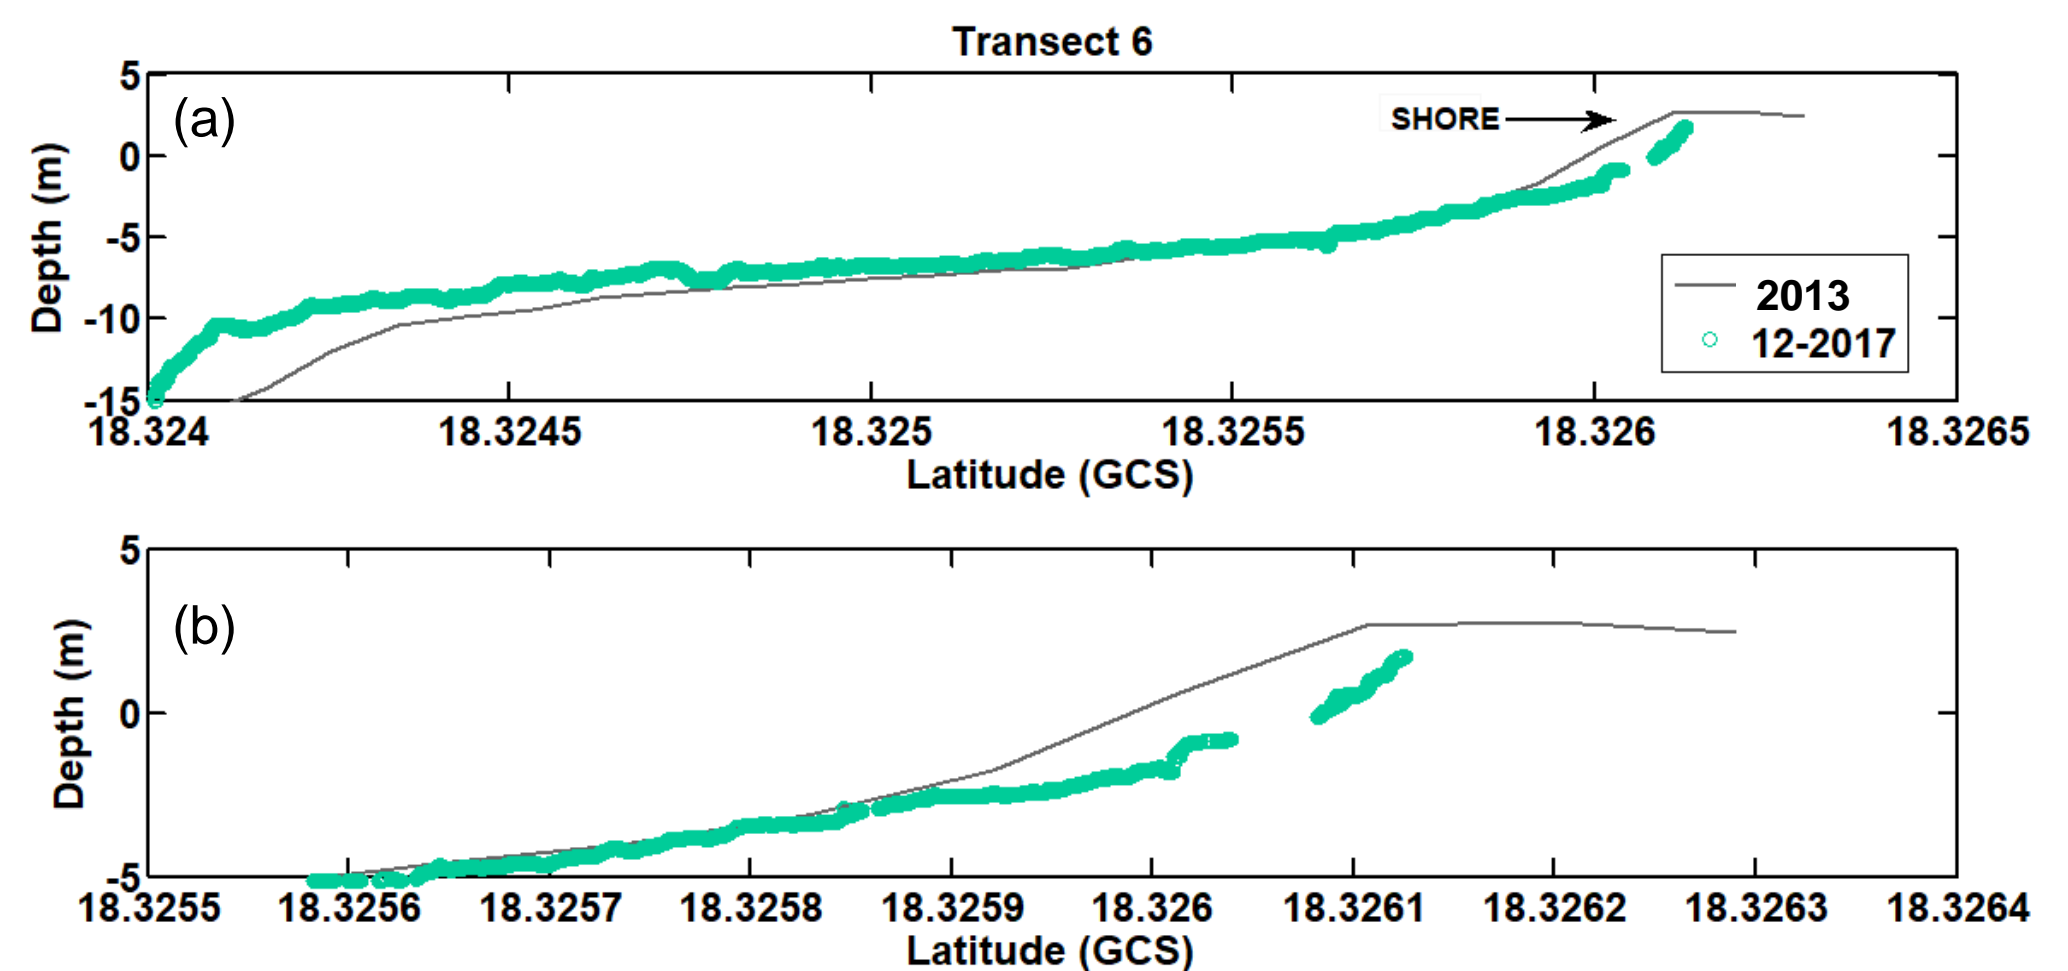
Comparison between the 2013 baseline beach profile (grey line) and post-storm beach profile (green circles) from (a) deep water to shore and (b) shallow water to shore.

- Storm waves coming in from a westerly/southwesterly direction generated offshore sediment transport (erosion) along the coast of Rincón.
- Significant sand deposition was observed between 200 to 350 meters away from the coast.

Thirteen beach profiles along the coast of Rincón have been collected since Hurricane María to quantify the nearshore morphological changes and to link the nearshore processes responsible for the quantified variability. Transect 6 is shown as an example to explain the morphological changes induced by the storm.
